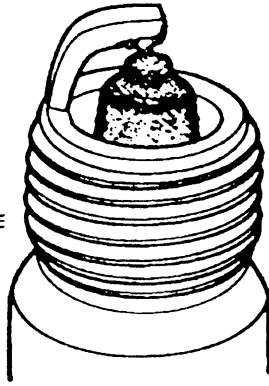
GAP BRIDGED

IDENTIFIED BY DEPOSIT BUILD-UP CLOSING GAP BETWEEN ELECTRODES.

CAUSED BY OIL OR CARBON FOULING. REPLACE PLUG, OR, IF DEPOSITS ARE NOT EXCESSIVE THE PLUG CAN BE CLEANED.

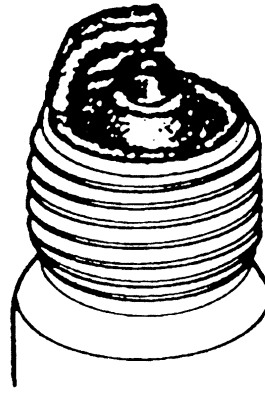
OIL FOULED

IDENTIFIED BY WET BLACK DEPOSITS ON THE INSULATOR SHELL BORE ELECTRODES.

CAUSED BY EXCESSIVE OIL ENTERING COMBUSTION CHAMBER THROUGH WORN RINGS AND PISTONS, EXCESSIVE CLEARANCE BETWEEN VALVE GUIDES AND STEMS, OR WORN OR LOOSE BEARINGS. CORRECT OIL PROBLEM. REPLACE THE PLUG.

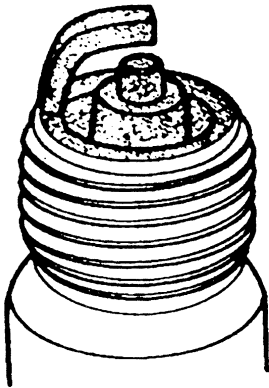
CARBON FOULED

IDENTIFIED BY BLACK, DRY FLUFFY CARBON DEPOSITS ON INSULATOR TIPS, EXPOSED SHELL SURFACES AND ELECTRODES

CAUSED BY TOO COLD A PLUG, WEAK IGNITION, DIRTY AIR CLEANER, DEFECTIVE FUEL PUMP, TOO RICH A FUEL MIXTURE, IMPROPERLY OPERATING HEAT RISER OR EXCESSIVE IDLING. CAN BE CLEANED.

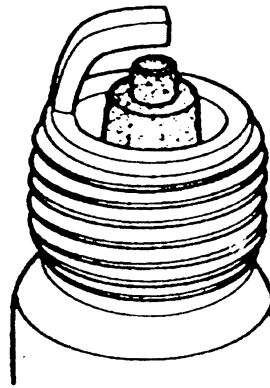
NORMAL

IDENTIFIED BY LIGHT TAN OR GRAY DEPOSITS ON THE FIRING TIP.

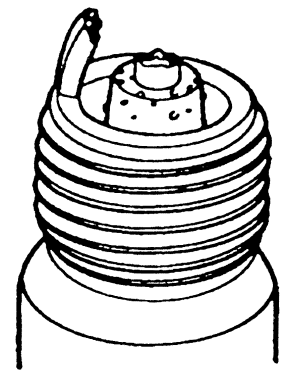
PRE-IGNITION

IDENTIFIED BY MELTED ELECTRODES AND POSSIBLY BLISTERED INSULATOR. METALIC DEPOSITS ON INSULATOR INDICATE ENGINE DAMAGE.

CAUSED BY WRONG TYPE OF FUEL, INCORRECT IGNITION TIMING OR ADVANCE, TOO HOT A PLUG, BURNT VALVES OR ENGINE OVERHEATING. REPLACE THE PLUG.

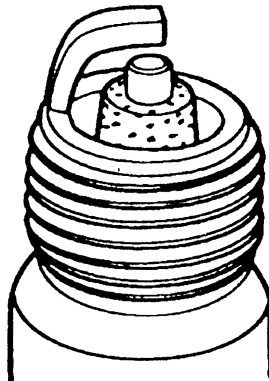
OVERHEATING

IDENTIFIED BY A WHITE OR LIGHT GRAY INSULATOR WITH SMALL BLACK OR GRAY BROWN SPOTS AND WITH BLUISH-BURNT APPEARANCE OF ELECTRODES.

CAUSED BY ENGINE OVERHEATING, WRONG TYPE OF FUEL, LOOSE SPARK PLUGS, TOO HOT A PLUG, LOW FUEL PUMP PRESSURE OR INCORRECT IGNITION TIMING. REPLACE THE PLUG.

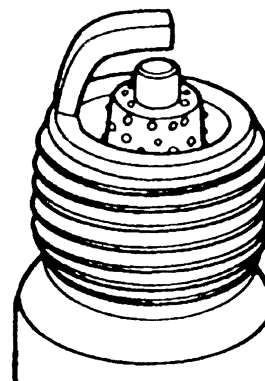
FUSED SPOT DEPOSIT

IDENTIFIED BY MELTED OR SPOTTY DEPOSITS RESEMBLING BUBBLES OR BLISTERS.

CAUSED BY SUDDEN ACCELERATION. CAN BE CLEANED IF NOT EXCESSIVE, OTHERWISE REPLACE PLUG.
